MARINE SAFETY ALERT

Alert 01-13

Counterfeit Portable Fire Extinguishers

BOW RIDING IN HEAVY WEATHER

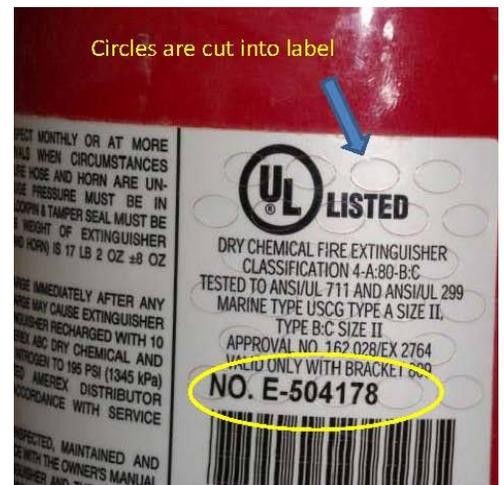
The labels on counterfeit extinguishers may be simply printed. Labels on genuine approved extinguishers will include a security imprint / texture behind the UL LISTED logo, classification, testing and approval data. Genuine Amerex Corporation extinguishers will have a pattern of scored "circles," and genuine Buckeye Fire Equipment extinguishers will have the letter "S" scored into the label.

The Coast Guard **strongly recommends** that vessel owner / operators inspect their equipment. Inspectors, surveyors, owner / operators and others suspecting that they may have identified counterfeit extinguishers should contact the Coast Guard Office of Design and Engineering Standards immediately. Please provide a description of the suspect units, including if possible photographs showing full front, rear, and bottom views of the extinguishers, along with close-ups of all labels, and submit this information to typeapproval@uscg.mil with a copy to anticounterfeiting@us.ul.com.

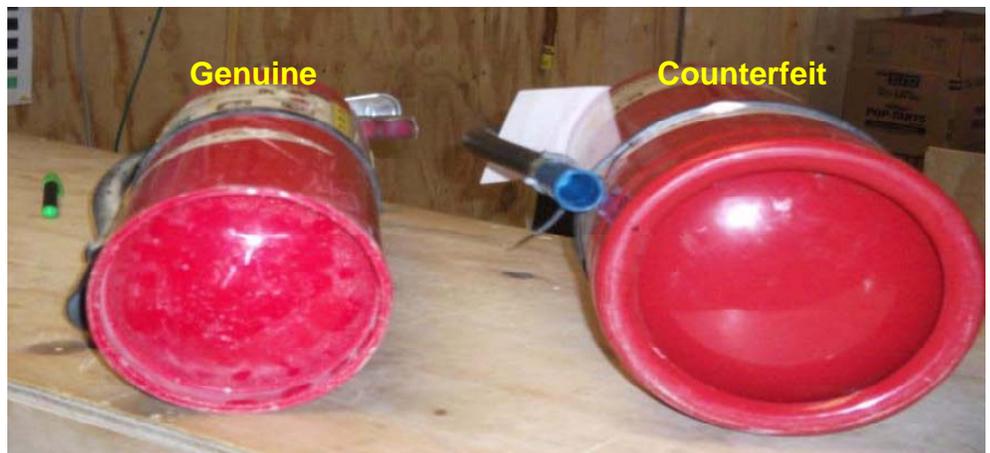
The bottoms of the counterfeits have a rounded curved-in lip as shown on the right side of the image on the right. The bottom of a genuine Amerex extinguisher is shown on the left side of the image. Genuine Buckeye extinguishers will have a date stamped on the bottom.

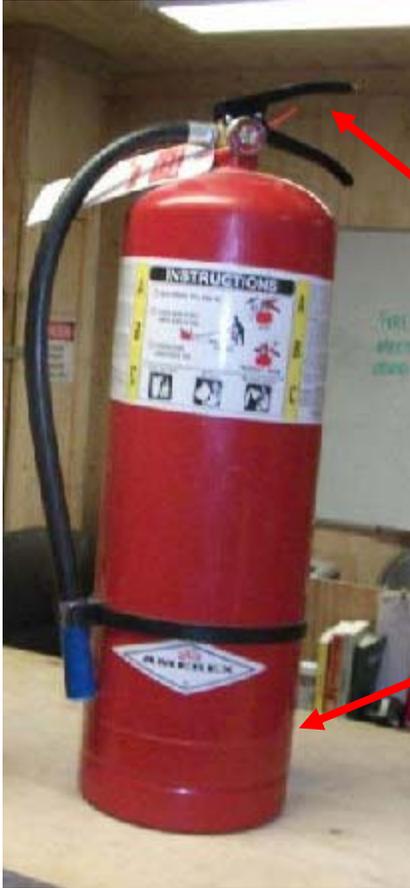
The counterfeit extinguishers have been reported to have black or red plastic handles. Genuine approved dry-chemical B-II extinguishers typically have handles that are constructed of silver-colored aluminum (although there are some with plastic handles).

Pressure gauges on the counterfeit units may be the wrong color. The gauges on genuine approved Buckeye dry-chemical extinguishers will have a red background.

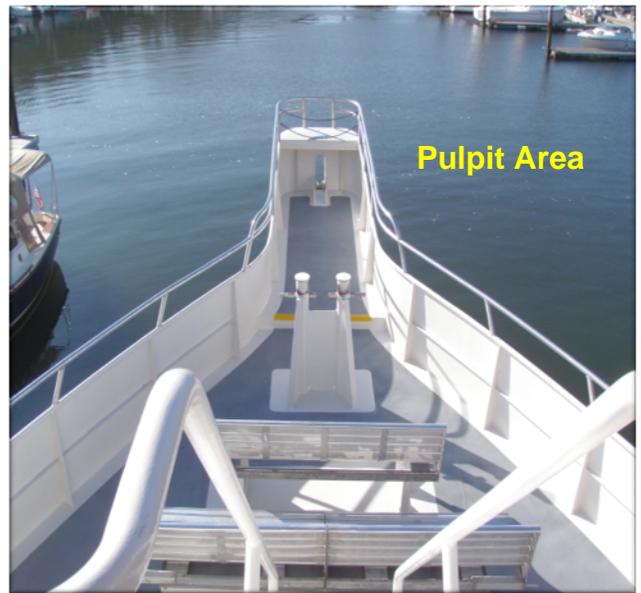
Several passengers standing in the bow pulpit of a 106' inspected whale watching vessel were injured while underway. The vessel struck a large wave, its bow rose and slammed down causing the passengers in the pulpit to lose their balance and fall to the deck. Injuries ranged from cuts and bruises to a broken patella (knee) and jaw. Although there were many other passengers on board at the time, only the passengers standing in the pulpit were injured.

- Proper verbal briefings regarding unfavorable weather conditions were made to the passengers; however, some passengers had disregarded these safety warnings.
- The vessel did not have a policy which outlined operational conditions as to when the bow area and pulpit should be vacated.

As a result of this casualty, the Coast Guard **strongly recommends** that all vessel owners/operators operating vessels with bow areas open to passengers establish written policy and procedures for vacating the area when operational conditions present risks of injury. The policy and procedures should address the vessel's speed and sea state, in addition informing passengers during the pre-departure safety brief of the restrictions prior to getting underway.
